## Geological and Geomechanical Properties of Abraha-Atsibha and Wukro rock-hewn churches and its surroundings, Tigray Region, Northern Ethiopia

**Asmelash Abay\*, Gebreslassie Mebrahtu and Bheemalingeswara Konka**

School of Earth Sciences, Mekelle University, P.O.Box:231, Mekelle, Ethiopia (\*asmelashby@yahoo.com).

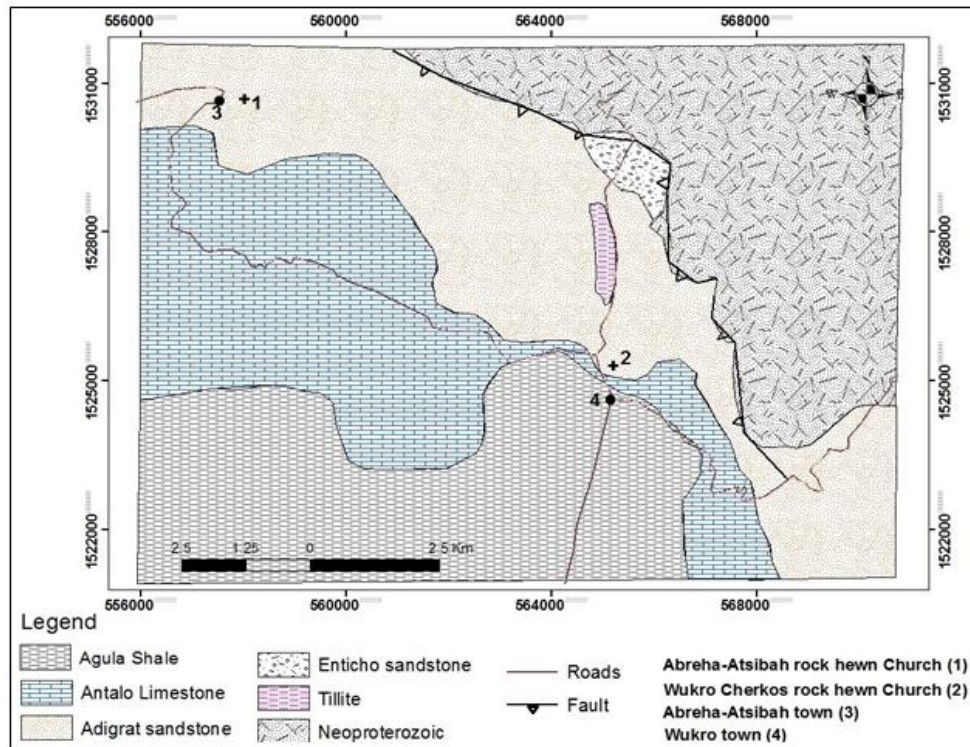
Figure 2. Geological map of the study area.

Enticho sandstone shows white color on fresh surface and grey to brown color on weathered surface. It is poorly sorted and consists of fine to coarse grain size texture (some places pebblesize), with silica cement and at places shows development of laterite. It is characterized by big cross-bedding sedimentary structures indicating paleo-current directions. Tillite on the other hand, is almost unsorted with the grain sizes varying from clay to boulder size. Presence of fine grained siltstone and clays tone layers together with coarse at places boulders of granite indicate fluvio-glacial depositional process. Striations present in minerals within the boulders further indicate the direction of glacial flow. The rock shows bands or layers of clays tones, mudstones, siltstones with different colors, varves are also common with variegated colors (Bosellini et al., 1997; Dow et al., 1971). Edaga-Arbi Tillite is inter-fingered with Enticho sandstone and underlies Adigrat sandstone. This rock unit covers very small area compared to other rocks and is mainly exposed in the northern part of the study area (Fig 2).

It covers northwestern part of the study area (Fig2) and is intercalated with shale and marl units. Its color varies from white to yellow, and shows micritic to medium grain texture. Being dominated by calcite mineral, dissolution cavities and karsts topography development is common as a result rock-water interaction (Fig 3). Different types of limestone rocks are observed namely, microcrystalline, karstic and fossiliferous (e.g. gastropods, bivalves, brachiopods and coral reefs) (Bosellini et al., 1997).

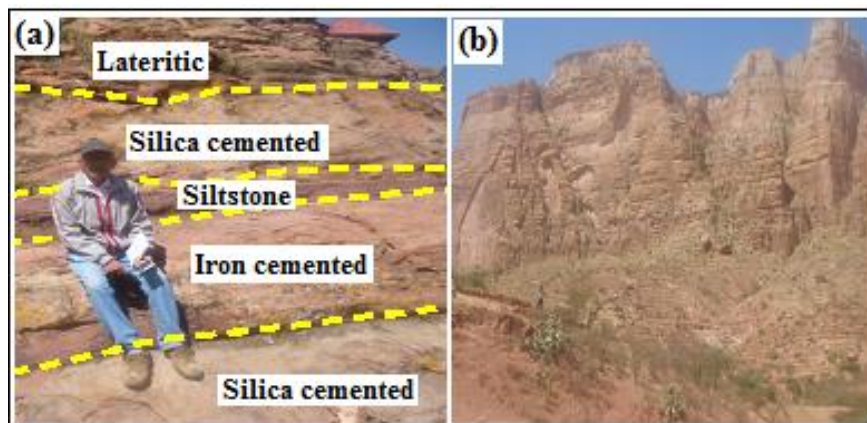
Figure3. Adigrat sandstone a) silica and iron cement dominated layers adjacent to Abreha-Atsibaha church; b) cliff forming Adigrat sandstone with well- developed fractures at Mariam Korkor area near Abreha-Atsibaha.

following the intersection of these joint sets. For example, wedge failure is common at the intersection of J2 and J3 at the sandstone cliffs (Fig 3b). Similarly, the characteristics of the major discontinuities (e.g. spacing, opening, joint condition) present in Adigrat sandstone, Enticho sandstone and Antalo limestone were collected and analyzed from the surface exposures and used in the RMR systems. These are the discontinuities that are facilitating mobility of rainwater or groundwater i.e. seepage into these churches.

Petrographic analysis of both Enticho and Adigrat sandstone though shows more or less similar mineralogical composition except in their cementing material and intercalated fine grained layers. Adigrat sandstone is characterized by (a) alternating bands of iron and silica cementing material (Figs 3 and 5); and (b) low to medium unconfined compressive strength. This means that the layers having different mechanical strengths respond differently to the surface processes i.e. the leaching of the cement. It is generally observed that iron is stable in the surface environment as iron hydroxide and produced lateritic layers. While silica is mobile in alkaline environments and remain stable in the normal pH conditions. Further, the response of thin layers of siltstones will be different from the sandstone as such. So, the iron rich siltstones layers and sandstone with iron cement seems to be relatively more liable to weathering compared to the silica cemented ones. Because of this it is common to see differential weathering in the cliffs and ridges of Adigrat sandstone exposed around Abraha Atisbaha and Wukro areas (Figs 1 and 2). Abraha-Atisbaha and Wukro Kirkos/Cherkos rock-hewn churches are carved into the Adigrat sandstone with both the iron cemented and silica cemented beds. Thus, it is common to observe different degree of spalling, pitting and discolorations in the interior parts of the pillars, walls

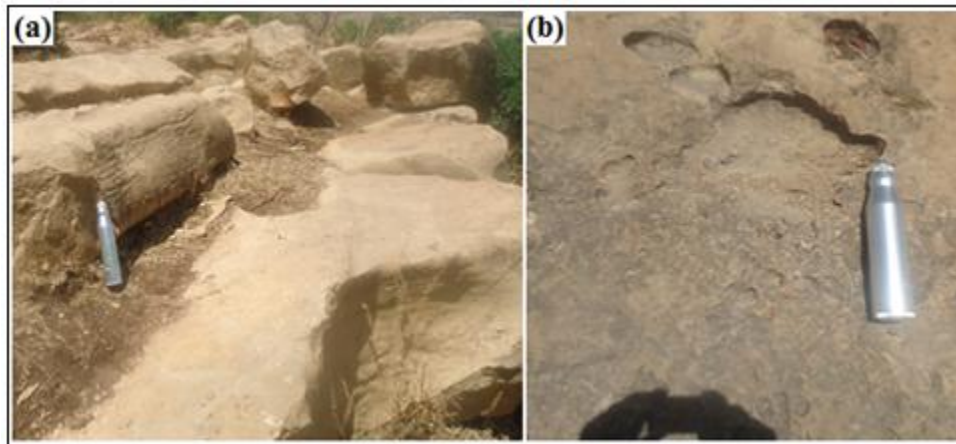
Figure 4. a) Microcrystalline limestone, and b) karst development in limestone.

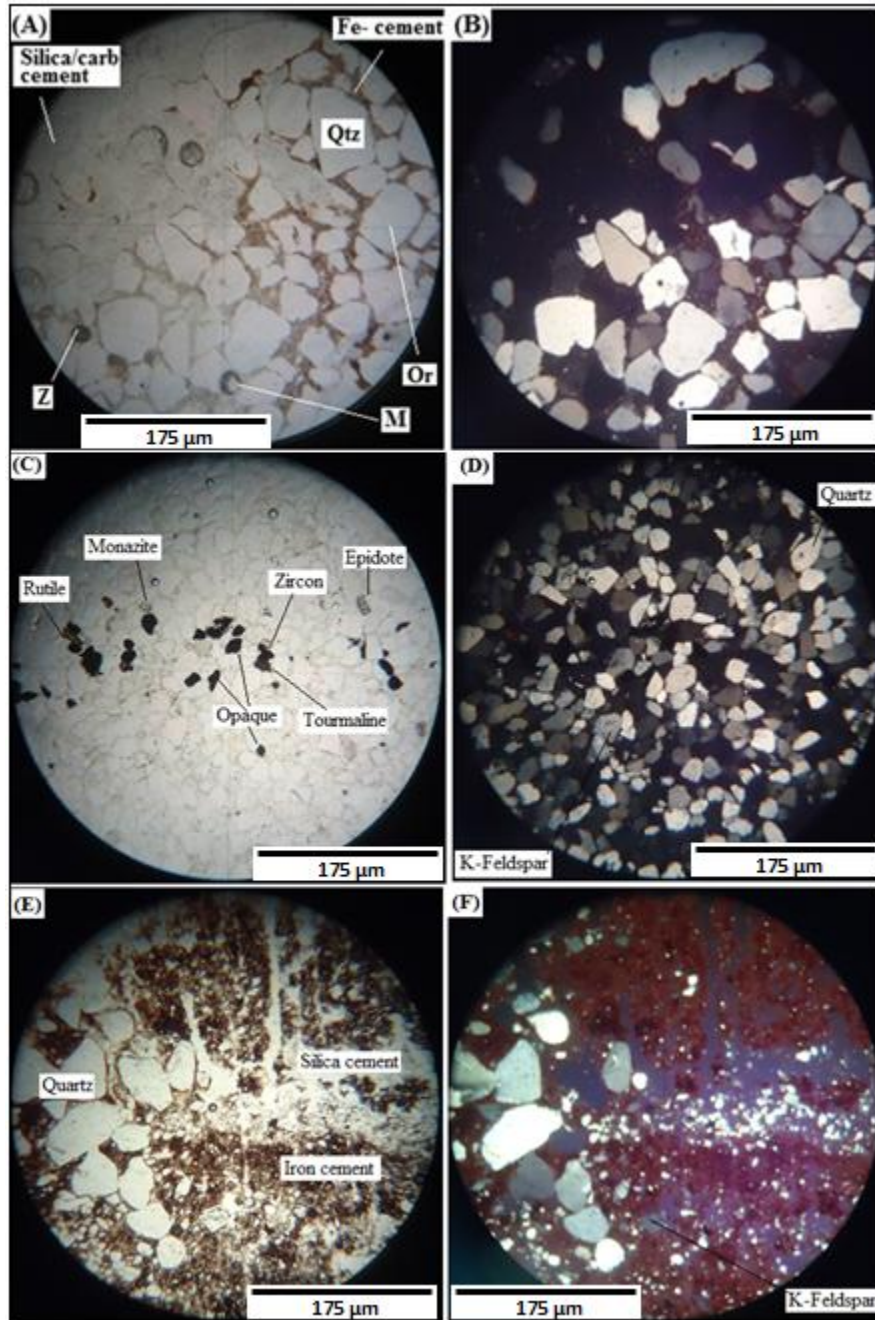
The rock-hewn churches under study though, are carved into Adigrat sandstone, both Adigrat and the Enticho sandstones were examined for mineral composition under transmitted light microscope. Petrographic details of Adigrat sandstone are shown in figure 5.

Figure 5. Microphotographs of Adigrat sandstone from Abraha-Atsibaha (40x); (A) red colored sandstone in PPL and (B) in XPL showing irregular to sub-rounded quartz (Qtz), irregular to rectangular orthoclase feldspar (Or), grains of monazite (M) and zircon (Z), and major part of the pore spaces are occupied by the iron (minor) and silica/carbonate (major) cement; (C) yellowish white sandstone in PPL and (D) in XPL, showing fairly sorted quartz dominated sandstone with K-feldspar and opaques and heavy minerals, rutile, zircon, monazite, epidote and tourmaline; (E) ferruginous sandstone with siltstone layer in PPL and (F) in XPL, showing iron oxide/hydroxide and silica cement with not well sorted quartz grains.

Petrographic data indicate that the Adigrat sandstone is composed of quartz (57-60%), orthoclase and plagioclase feldspars (12-20%), opaques and heavy minerals (~3%), and pore spaces (~5%).

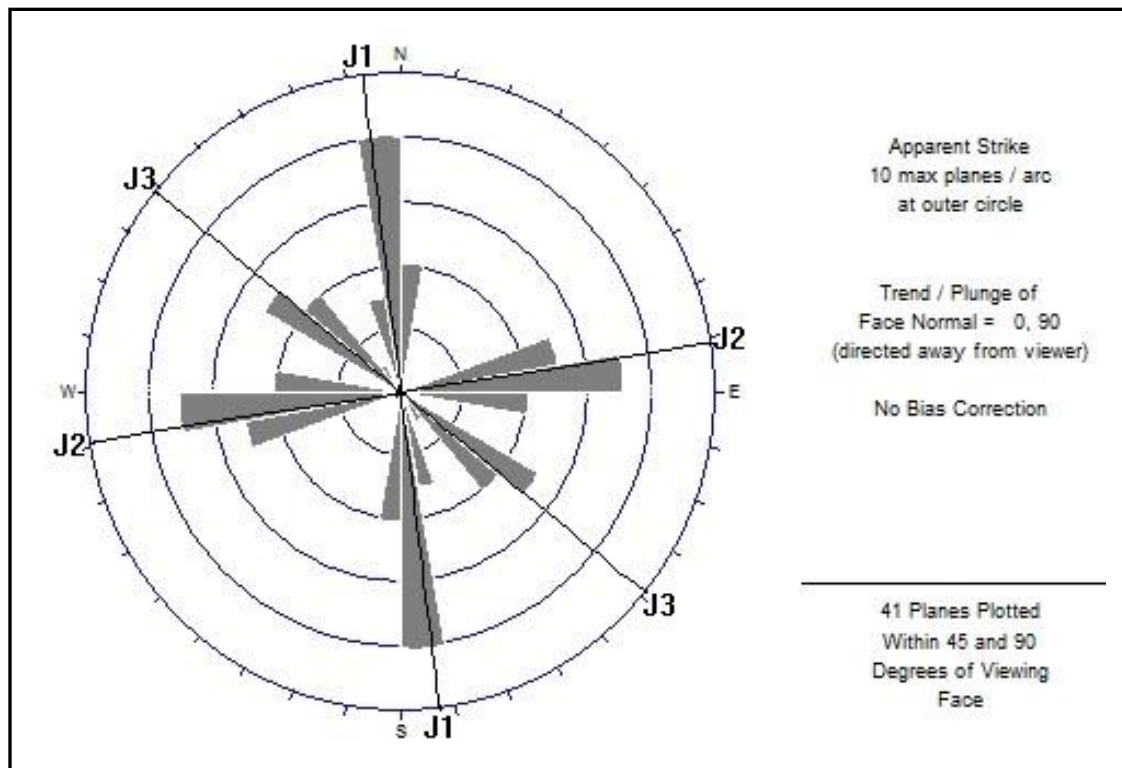
Figure 6. Rose diagram showing the trend of joints in the rock exposures (n = 41).

Two to three major joint sets observed in different exposures in the study area were measured and the data is given in table 1 and their trends are shown in figure 6. It is common to see the rock falls of different sizes at the cliff forming Adigrat sandstone and Antalo limestone rocks units

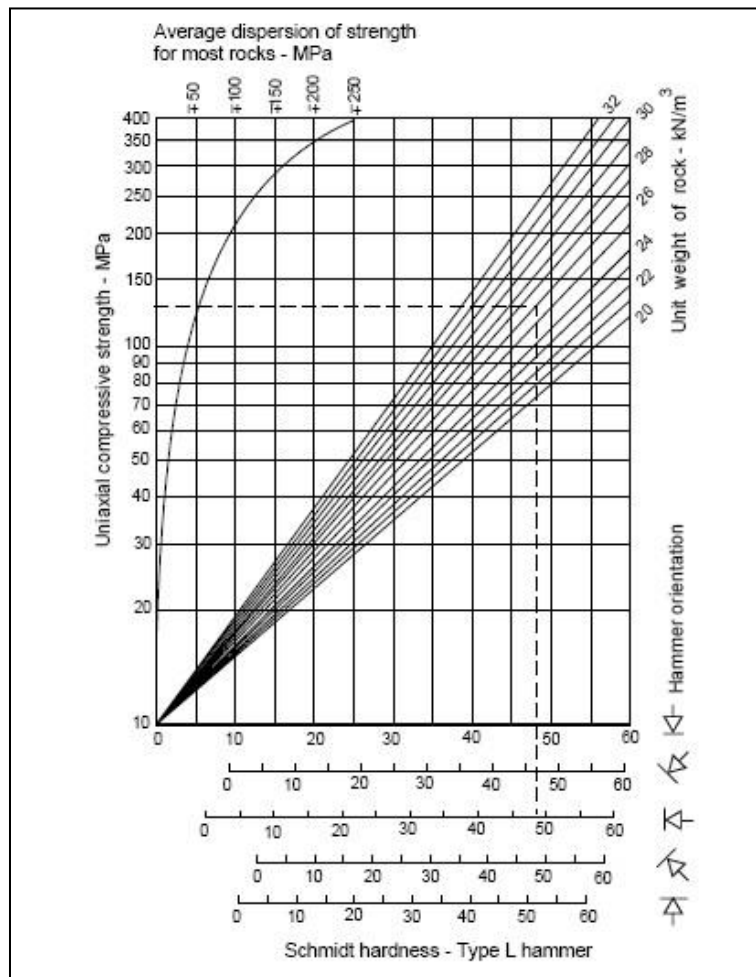
Figure 7. Graph used to convert the Schmidt hammer rebound number to UCS of rocks.

Schmidt hammer rebound test is used to measure where a number of readings were taken in the field. As suggested by ISRM (1978), the readings were ordered in increasing order of magnitude and the first five minimums dropped, and the mean of the last five maximums is taken as representative of the Schmidt hammer rebound test. The UCS is taken from the established correlations of the hardness number against uniaxial compressive strength chart. The value of compressive strength is obtained from the Deer-Miller graph showing its dependence on the rock strength found from the Schmidt hammer measurements as shown in figure 7. Based on the above

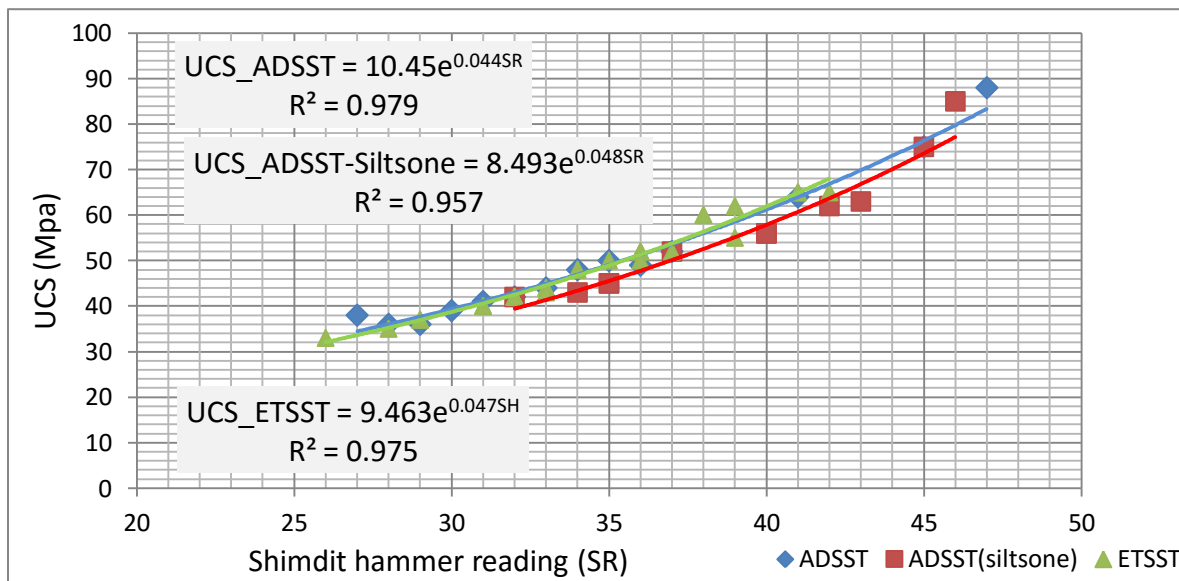
Figure 8. Relation of UCS to Schimdit hammer rebound test for rocks of the study area.

**Note:** ADSST =Adigrat sanstone; ETSST = Enticho sandstone.

According to Bieniaswki (1973), a rock is said to be very low strength if its UCS value is <25MPa; between 25 to 50Mpalow strength; 50 to 100 MPa medium strong; if its value lies between100 and 250 Mpa high strength; and>250Mpais very high strength. From this perspective, the strength of both Adigrat and Enticho sandstones vary from very low strength to medium strength (Table 2). Statistically, 45 % and 55% of the Adigrat sandstone falls in the low and medium strength ranges while 33 % and 67% of the Enticho sandstone lies in the low and medium strength value ranges respectively. Similarly, analyzed strength results of limestone showed that its UCS varies from 160 to 240, which is of high strength rock as it is very crystalline rock. The strength of the limestone is three times higher than that of the sandstones (Table2) and Enticho sandstone relatively shows higher strength than Adigrat sandstone (Fig 8). From excavation point of view, it is relatively easier to manually excavate in the two sandstones than in the limestone. This could be one of the reasons why all rock churches in the study area are found in both sandstones but none in other rock out crops.

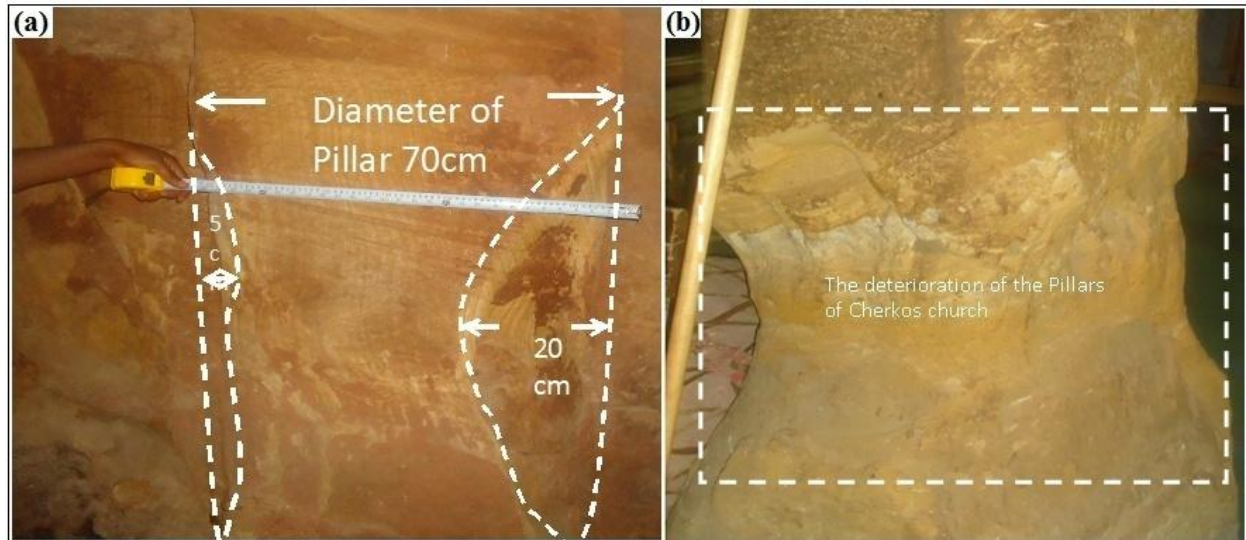
Figure 9. Showing (a) deterioration of one of the pillars of Abraha-Atsibah church; and (b) deterioration of one of the pillars of Wukro Kirkos/Cherkos.

and roofs of the churches (Fig 9a and b). This clearly suggests that the continuity of weathering of this nature if continues for long periods of time will deteriorate the rocks in the walls etc and ultimately affect these churches.
